Manhole Inspection Summary

Manhole # S29K__015MH

Insp Date: **10/29/08 12:35 PM**

Location Address: **705 Portland St.**

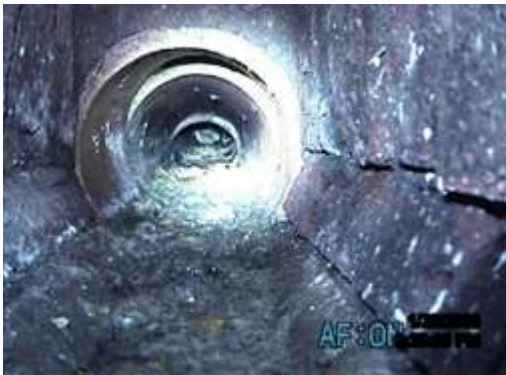
Misc

pipe sections have shifted apart

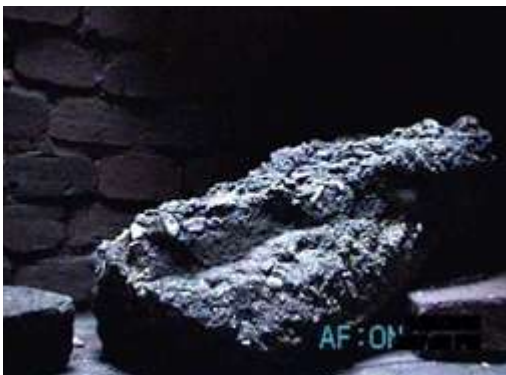
Defect 2

Condition: ☐ Sound ☐ Cracked ☐ Root Intrusion ☐ Deteriorated ☐ Leaks ☒ **Debris**

large debris on bench

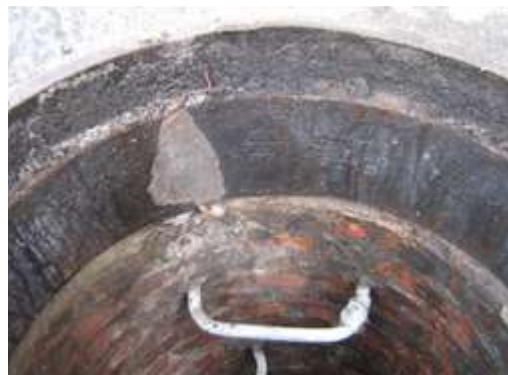
Defect 1

☒ **Leaks**

Infiltration: ☐ None ☐ Joint ☐ Cracks ☐ Mortar ☐ Roots ☒ **Wall**

frame leaks, chimney infiltration

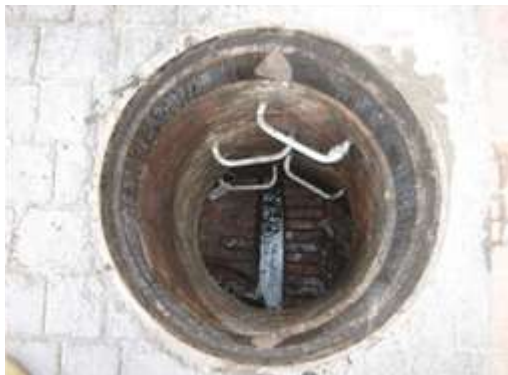
Defect 4

frame leaks

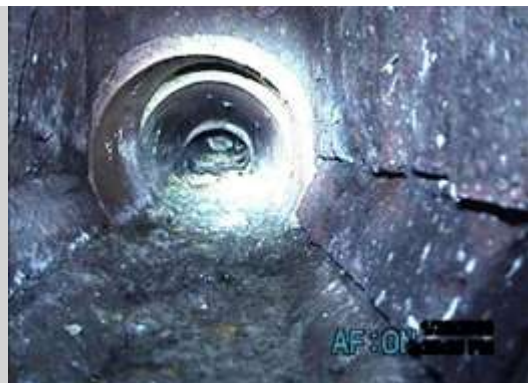
6 O'Clock Inflow

pipe sections have shifted apart

Deposits: ☐ None ☒ **Mud** ☐ Sludge ☐ Debris ☐ Grease

Silt Depth: **2** (in.) Deposits Extent: **Medium**
